## **6.4 Damage to Steel Gymnasiums**

### **6.4.1 Introduction**

### **6.4.2 Outline of damage investigation of steel gymnasiums**

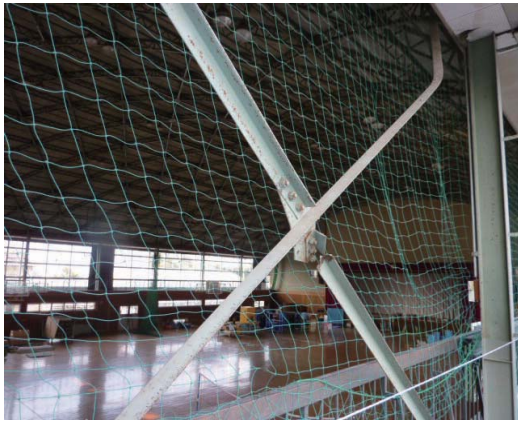
Buckling of brace member (Photo 6.4-1) and fracture of brace joint (Photos 6.4-2 ~ 6.4-4) were observed. Angle section was often used for many brace members, but circular hollow section steel (Photo 6.4-3) was also used for brace members. Fractured sections include steel plate inserted into steel pipe, end of bracing member and section loss part by bolt hole. These types of the damage are classified into the severe damage category based on the damage evaluation standard<sup>6.4-4)</sup>. The number of the gymnasiums of this type is 3. The gymnasiums constructed under the previous seismic code that had been severely damaged by the Mid Niigata Prefecture Earthquake in 2004 had accounted for about 30% of the total<sup>6.4-1)~6.4-3)</sup>. It is impressed that a rate of the gymnasiums severely damaged by the 2011 Tohoku earthquake was lower than by the Mid Niigata Prefecture Earthquake in 2004.

Photo 6.4-1 Buckling of brace

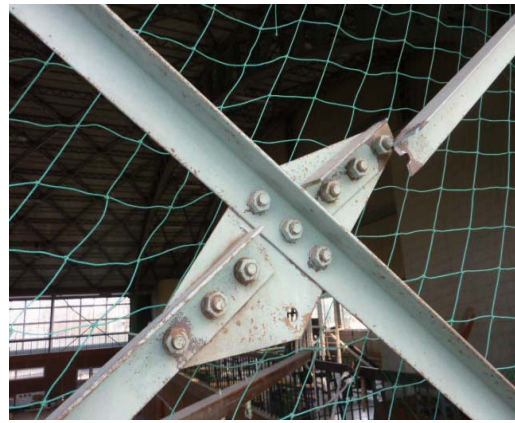
Photo 6.4-2 Net section fracture at bolt hole

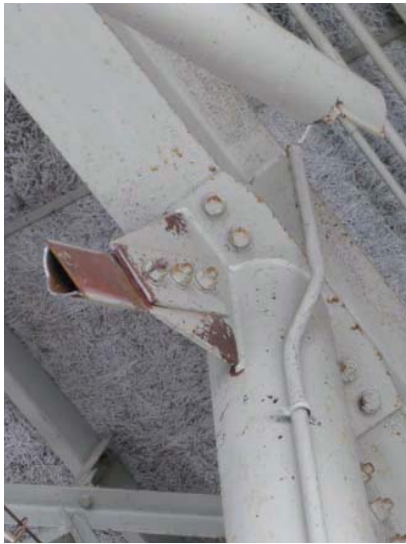
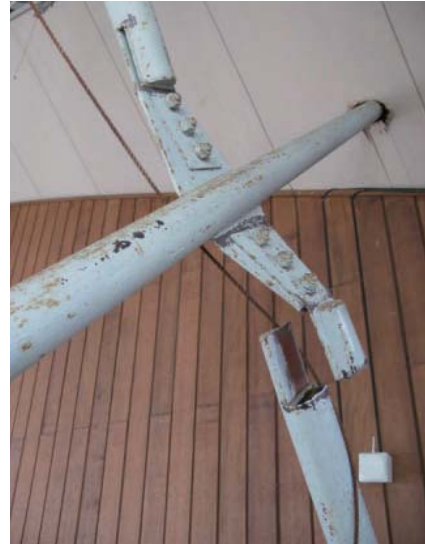
(a) Fracture at column top

(b) Fracture at brace crossing

Photo 6.4-3 Fracture of brace welded connection

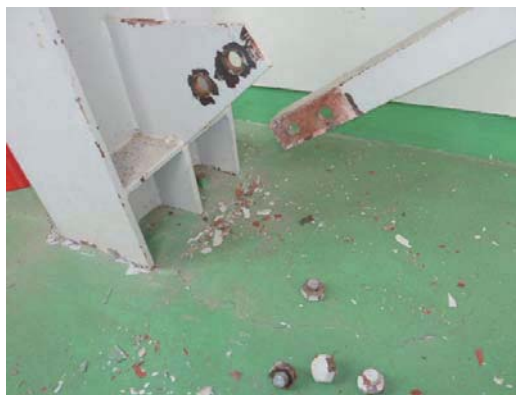
Photo 6.4-4 Fracture of bolts

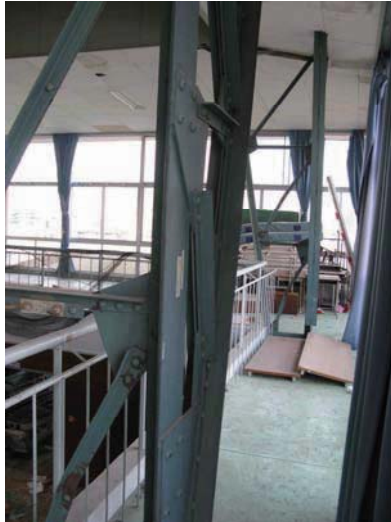
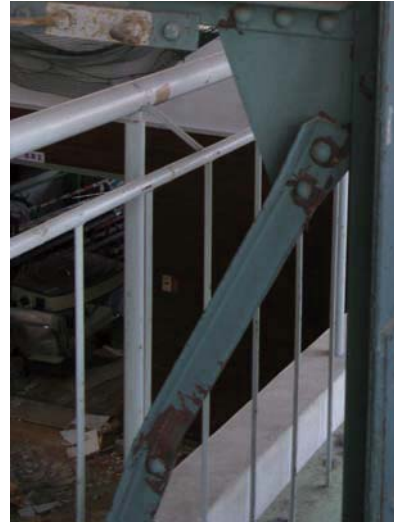
In one of the investigated gymnasiums, buckling of diagonal members in some latticed columns was observed (Photo 6.4-5). Damage of column buckling caused in steel frames for span direction had not been observed under the damage investigations of the Mid Niigata Prefecture Earthquake in 2004<sup>(6.4-1)~(6.4-3)</sup>.

(a) Latticed column

(b) Buckling of diagonal member

Photo 6.4-5 Buckling of diagonal member of latticed column

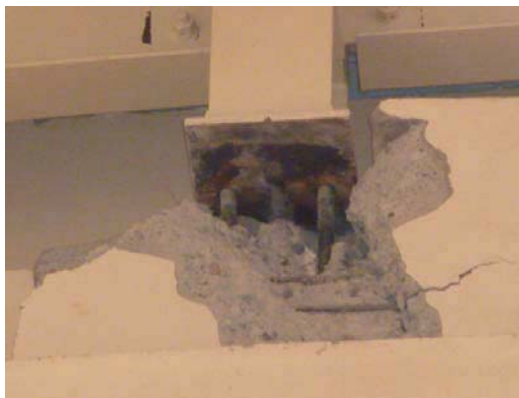
In the investigated gymnasiums, exposure of anchor bolts due to spalling of the concrete at connection (bearing support part) between the RC column and steel roof frame (Photos 6.4-6 and 6.4-7), spalling of finish mortars on the RC column at the roof bearing support part, and pullout of hole-in anchors (Photo 6.4-8) were often observed.

Photo 6.4-6 Spalling of concrete

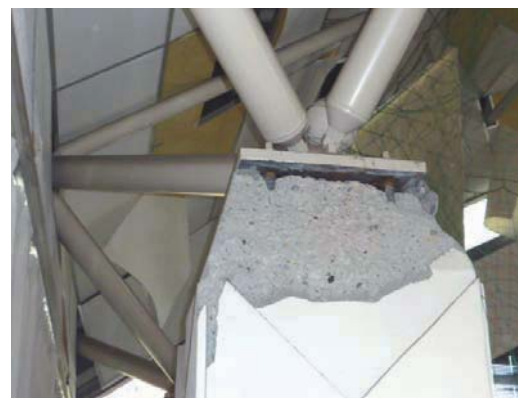
Photo 6.4-7 Spalling of concrete

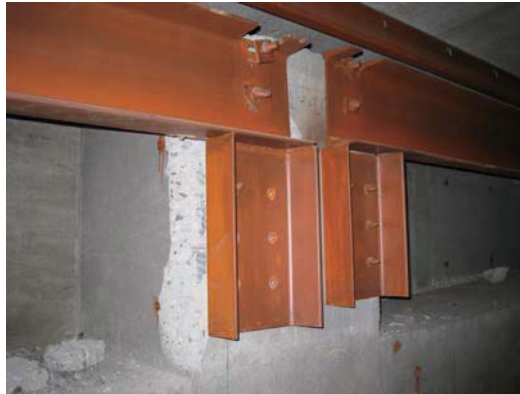
Photo 6.4-8 Pullout of hole-in anchors

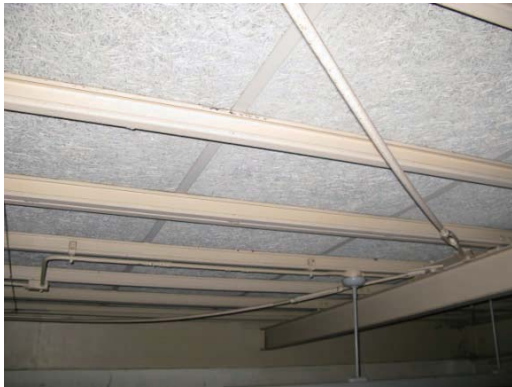
Roof horizontal braces were damaged in two high school gymnasiums and five elementary and junior high school gymnasiums. Such damage mainly occurred at horizontal braces with turnbuckles; obvious deflection of the horizontal brace (Photo 6.4-9) and fracture at thread and fracture of bolt connections were observed (Photo 6.4-10).

Photo 6.4-9 Deflection of horizontal braces

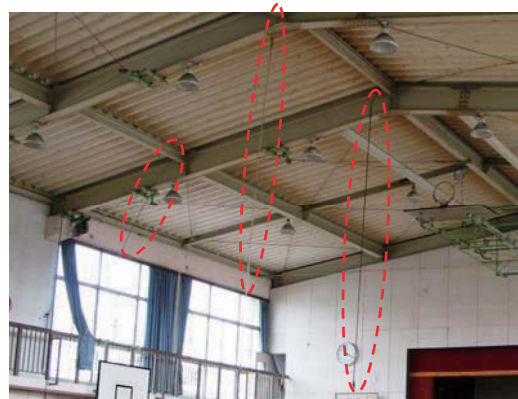
Photo 6.4-10 Fracture of horizontal braces

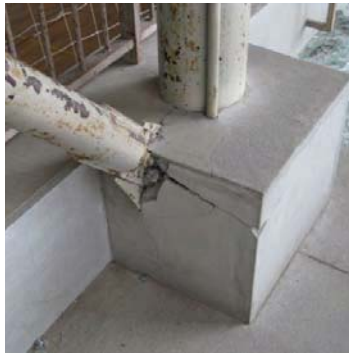
Damage of cracking of the column base concrete and mortar in the gallery of some gymnasiums was observed (Photo 6.4-11). Concrete and mortar of steel column base at a ground level was also cracked (Photo 6.4-12). However, almost all of these cracking are classified into minor or slight damage.

Photo 6.4-11 Cracking of column base concrete

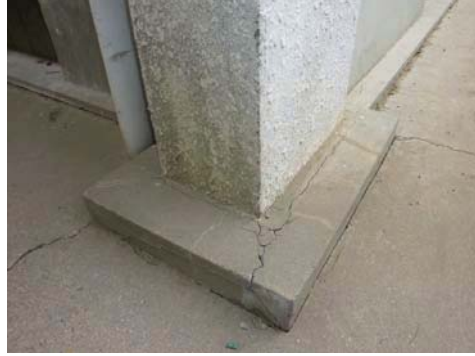
Photo 6.4-12 Cracking of column base concrete

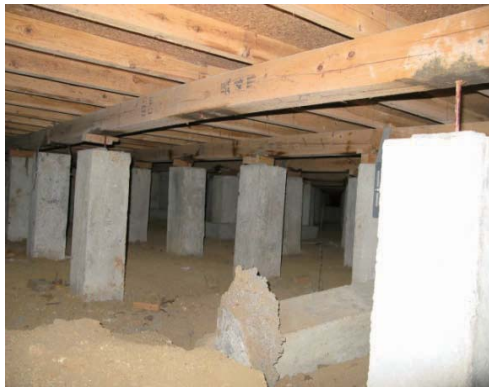
As the other types of the structural damage, the following damage was observed; (a) overturning of floor strut (Photo 6.4-13), (b) tilting of concrete block self-standing wall and (c) peeling of paint of beam members which was observed near the top of the V-shaped roof beams or arch beams (Photos 6.4-14 and 6.4-15). In terms of the peeling of paint, it was uncertain whether yielding of the beams occurred or not.

Photo 6.4-13 Overturning of floor strut

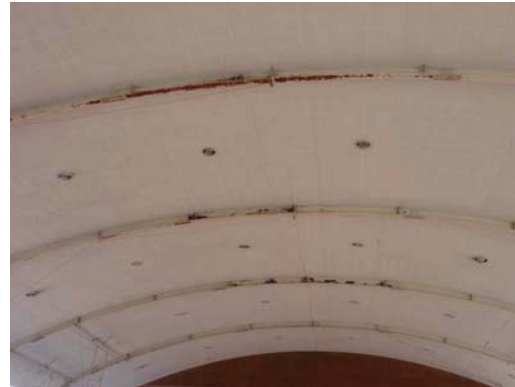
Photo 6.4-14 Peeling of paint of beams

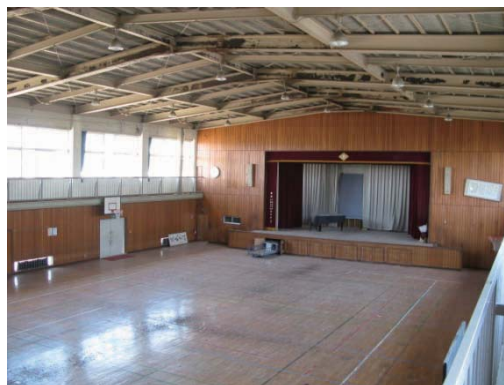
Photo 6.4-15 Peeling of paint of beams

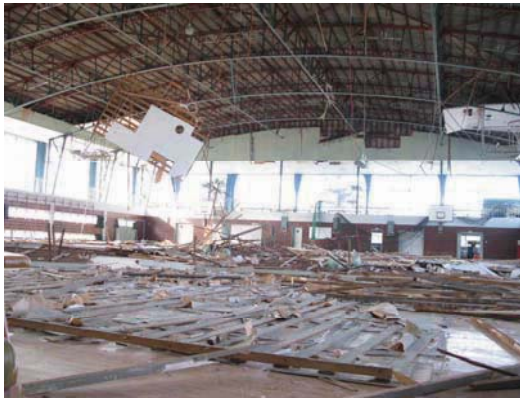
The types of nonstructural damage of gymnasiums included dropping of ceilings and lighting equipment (Photos 6.4-16 ~ 6.4-18), breakage of windows (Photo 6.4-19), dropping of exterior walls (Photo 6.4-20), dropping of interior walls and eave soffit (Photo 6.4-21). In particular, the severe damage such as dropping of extensive ceiling in the high school gymnasiums was observed more than in the elementary and junior high school gymnasiums.

Photo 6.4-16 Dropping of extensive ceiling components

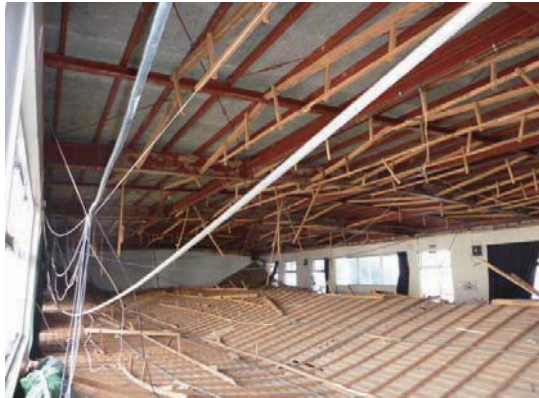
Photo 6.4-17 Dropping of extensive ceiling components

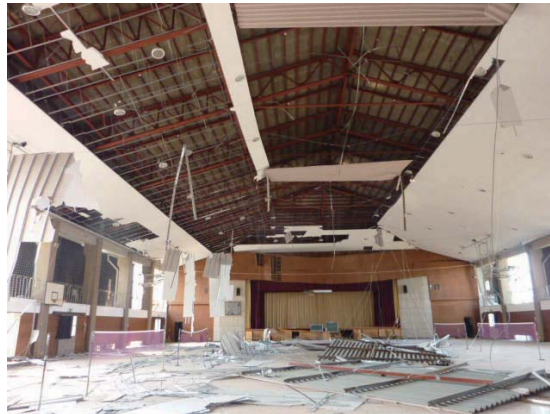
Photo 6.4-18 Dropping of extensive ceiling components

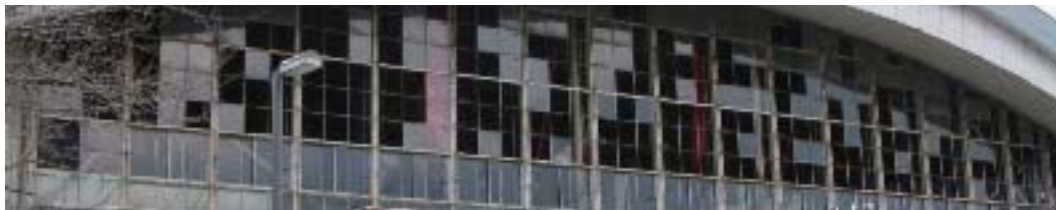
Photo 6.4-19 Breakage of windows

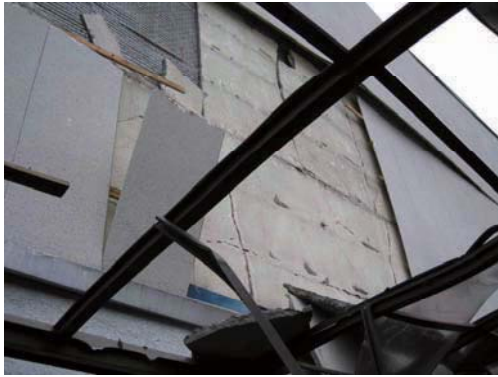
Photo 6.4-20 Falling of exterior finish components

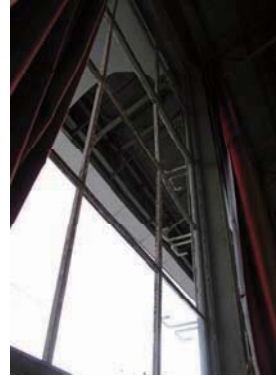
Photo 6.4-21 Falling of eave soffit
