Just How Good Is Wood?

Wooden buildings constructed with traditional techniques show remarkable seismic resistance. **Kawai Naohito** of the Department of Structural Engineering at the Building Research Institute explains what we might learn from these buildings based on the results of tests being conducted in Japan.

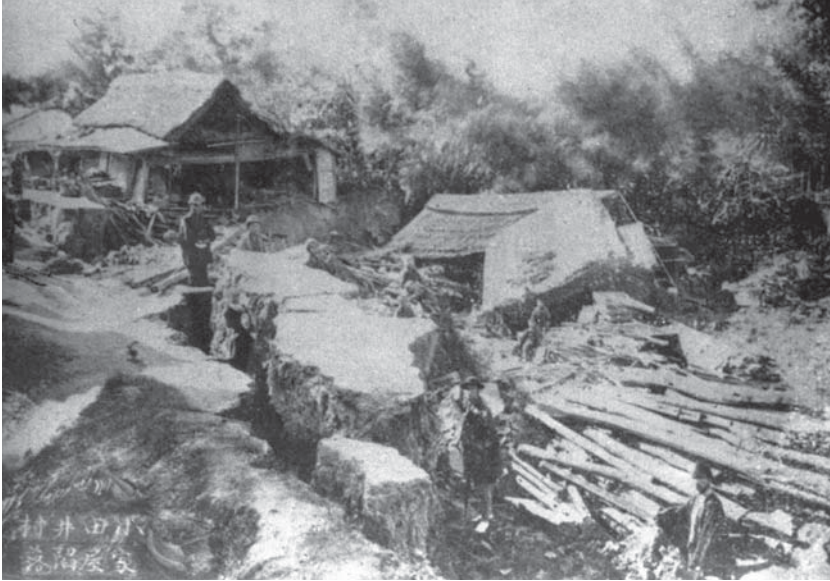
Damage to wooden buildings in the Nobi earthquake of 1891, centered on Gifu and Aichi prefectures

With regard to seismic resistance in traditional wooden buildings, the first scientific survey of earthquake damage was probably carried out after the Nobi earthquake in 1891. The seismic survey of the seismic resistance of residential dwellings was undertaken by Josiah Conder, a British architect working and living in Japan. He identified issues such as the lack of diagonal bracing in the walls, the lack of foundations, and heavy roofs.

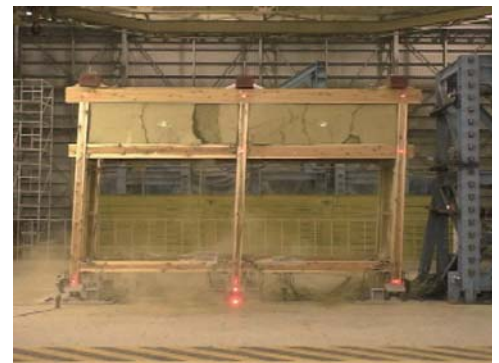
Test situation: When the logs are thick, the wall in the upper section is destroyed.

Institute on open frames featuring clay walls only in the upper section. The situation varies depending on the thickness of the logs or whether the plinths are fixed or not. If the diameter of the posts is a fairly thick 150 mm, the clay wall is destroyed, but if the diameter is a fairly thin 135 mm, the posts snap. Also, if the

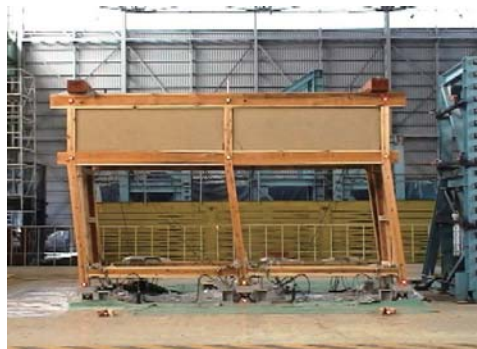
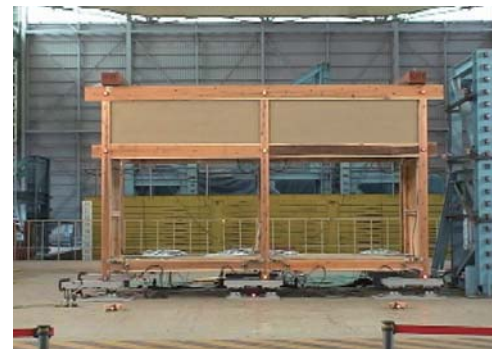
When the circumference of the post is a size thinner, the post snaps. If the plinth slides, however, there is little damage.

posts are simply placed on top of the stone without fixing in place, the plinths slide on top of the stone resulting in little damage to the frame.

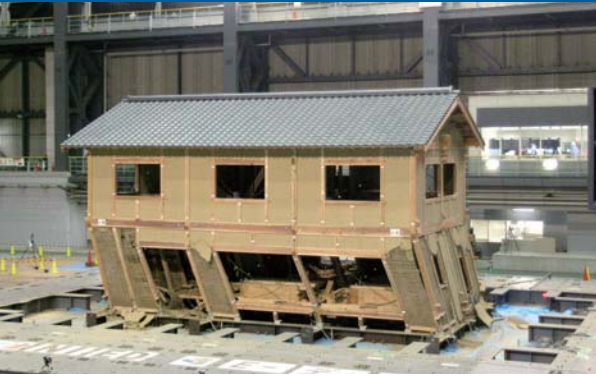
Vibration testing of a two-story full-size wooden home. (Research project by the Ministry of Land, Infrastructure, Transport and Tourism, 2008.)

Among the research projects funded by the Government, there are also those that carry out vibration testing on full-size traditional wooden houses. The photographs show the results of applying huge seismic motion to observe the state of destruction after confirming adequate performance at the standard of assumed seismic motion. In this regard, the graph shows an example of the analytical model and the results of analysis undertaken at the Building Research Institute using the Distinct Element Method. Using a 3-D model based on testing of components such as the clay wall and the connecting parts, it is possible to predict seismic response with considerable accuracy.

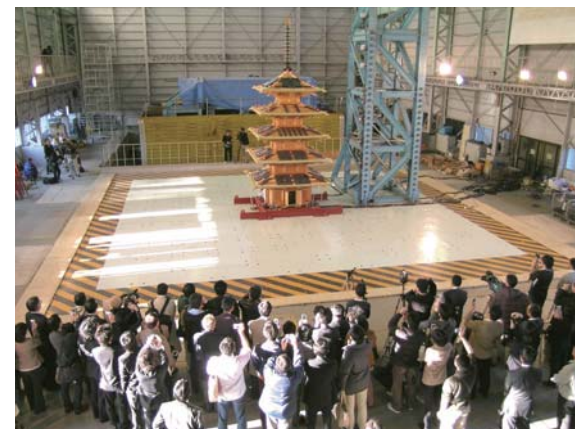
Vibration testing of a mockup of a five-story pagoda. (Forum for Wood Architecture and the National Research Institute for Earth Science and Disaster Prevention, 2004.)

Research such as vibration measurements, manpower excitation and strong motion observation has been carried out on pagodas to find an engineering explanation for the seismic resistance of the five-story pagoda. So far, these measurements have been done on the twenty-two extant five-story pagodas built before the Edo period (1603–1867). In recent years, we have also carried out vibration testing, not on full-size pagodas, but on mockups scaled down to one fifth the size of a five-story pagoda (6.4 meters). In terms of normal seismic motion, it is clear that replicating the type of oscillation where all stories incline in the same direction is difficult, and that there is no major variation even if the shape of the central pillar of the pagoda is changed.

On the basis of this research, the reason five-story pagodas seldom collapse in earthquakes is that they sway slowly because of the height of the pagoda itself, which is

about 30 meters. As a result, the foremost reason is that in normal seismic motion where many components sway minimally, resonance is not easily induced.
